# Manhole Inspection Summary

Manhole # S31K\_\_014MH

**Location** Address: **S Paca St**

Cross Street: **Warner St**

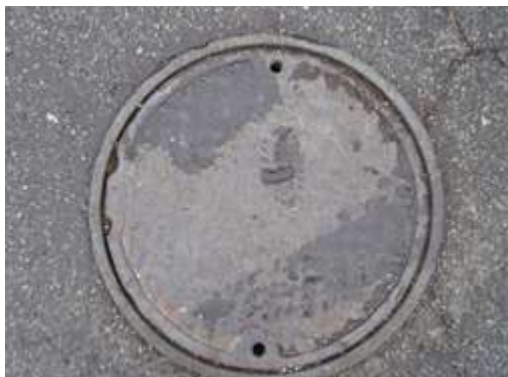
Misc

cover

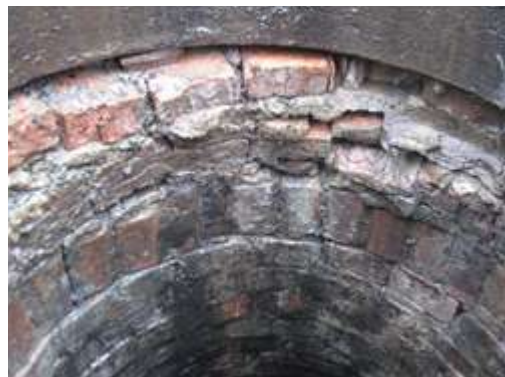
Defect 7

chimney cracked and loose bricks,  
infiltration at both frame seat and wall  
cracks

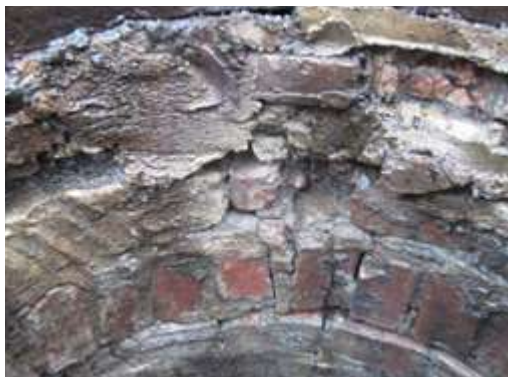
Defect 6

chimney deteriorated, infiltration at joint

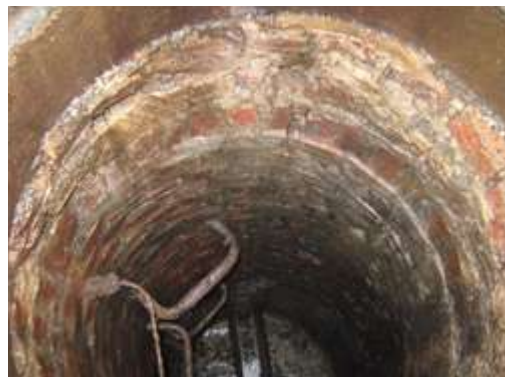
Defect 5

steps corroded

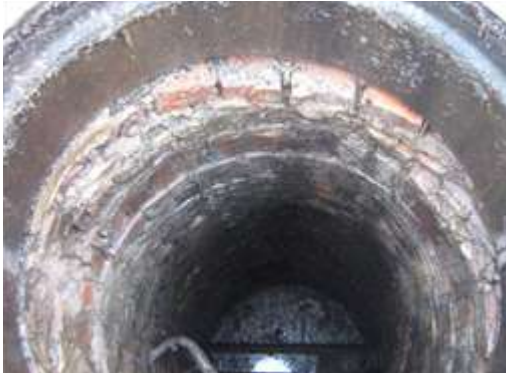
Defect 4

corbel deteriorated and infiltration at wall

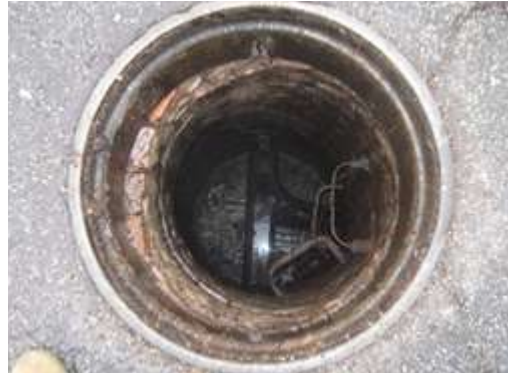
Defect 1

frame offset 2", leaks around cover

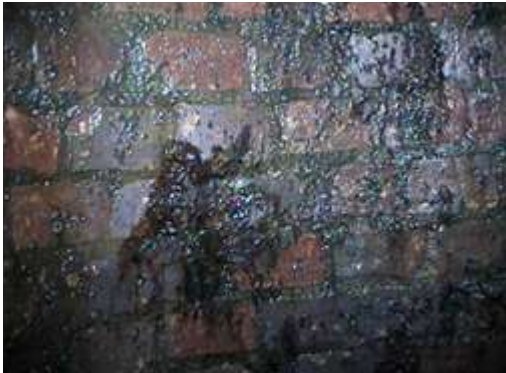
Defect 3

barrel deteriorated, infiltration at wall

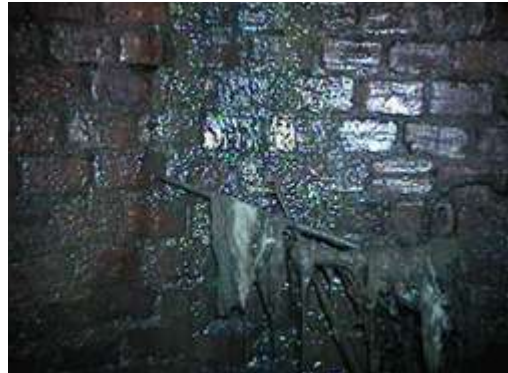
Defect 2

surcharge 3.5 feet

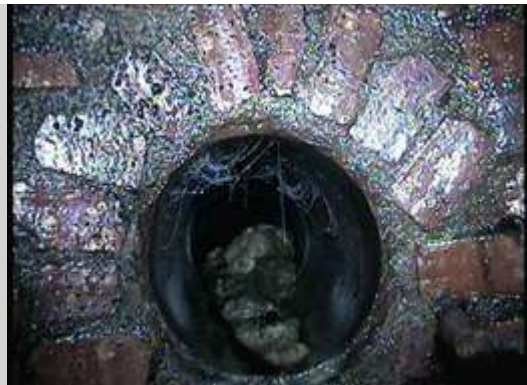
3 O'Clock Inflow

Pipe Height: **8.4** (in.) Rod and Bar (Angled)  
Pipe Material: **Clay** ☐ Pipe Lined  
Invert Depth: **9.84** (ft.) Flow Characteristics: **Slow**  
Deposits: ☐ None ☒ **Mud** ☐ Sludge ☒ **Debris** ☐ Grease  
Silt Depth: **1** (in.) Deposits Extent: **Medium**  
Infiltration: **None** Pipe Seal Cond: **Sound**
